Don & Sandy Billish Park

15601 Gypsy St. Corpus Christi,
Texas 78418

Pavilion and Amenity Repair Needs

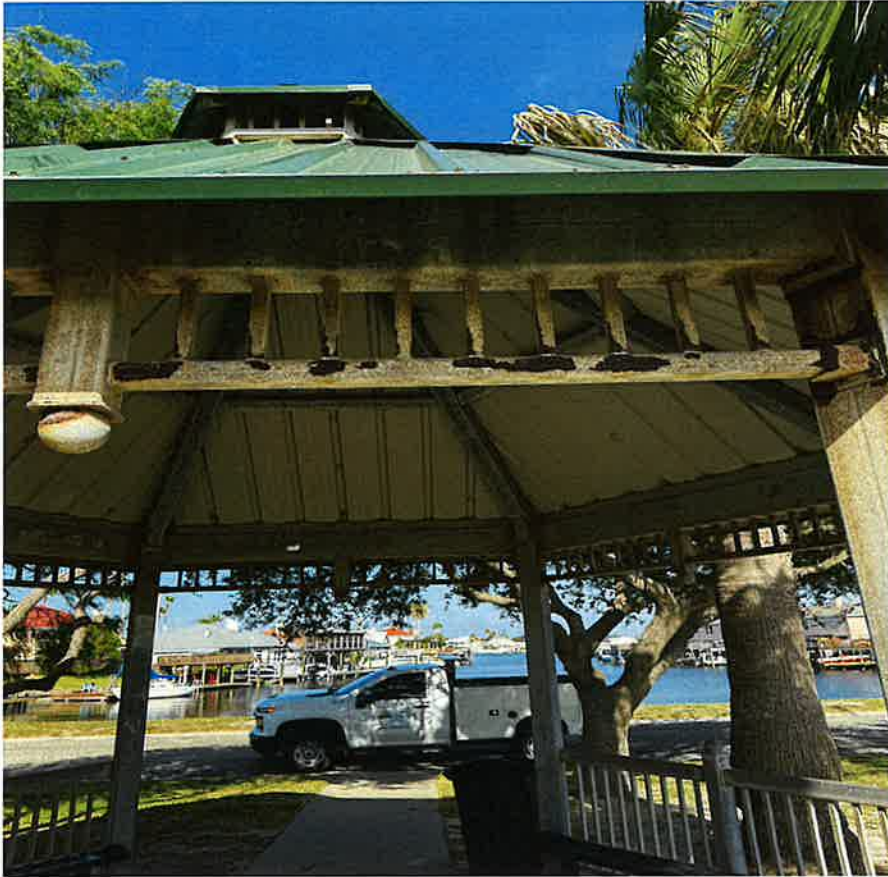
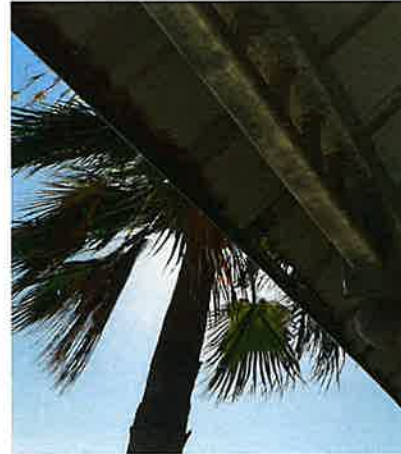
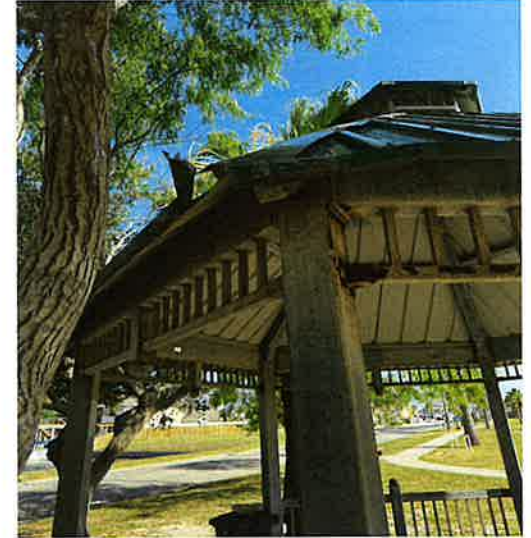
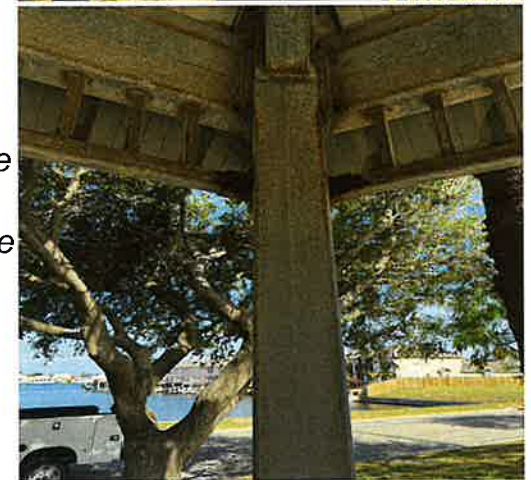
Pavilion Structure

The pavilion structure will require repairs, which will need to be sourced to a contractor to ensure all necessary work is properly addressed.

- Wood components show signs of dry rot and deterioration
- Roof (metal) is damaged in multiple areas
- Wood appears potentially hazardous and may pose a safety risk
- Pavilion needs a structural assessment to determine safety and repair scope

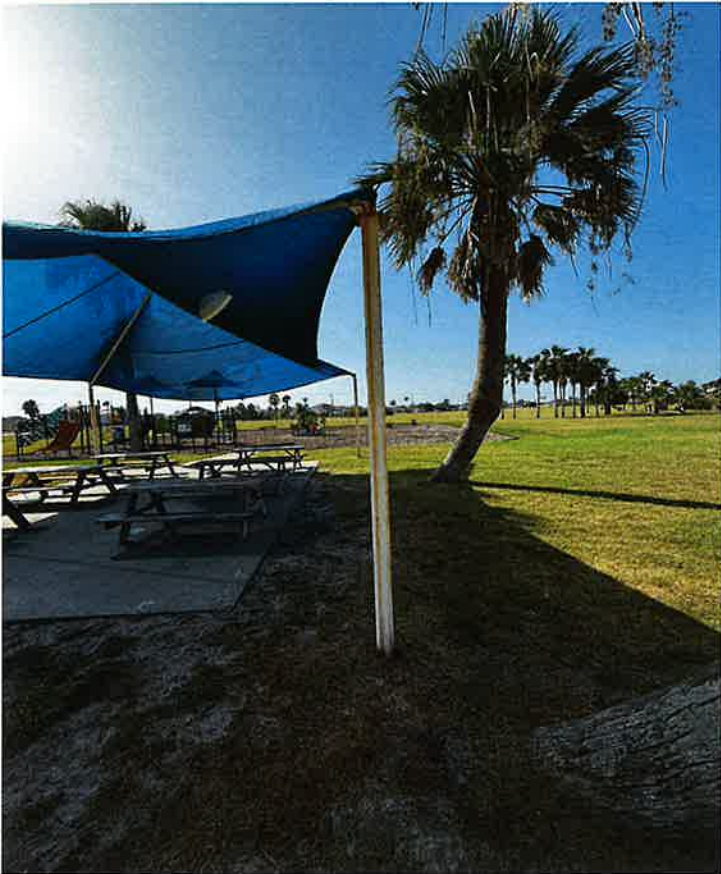
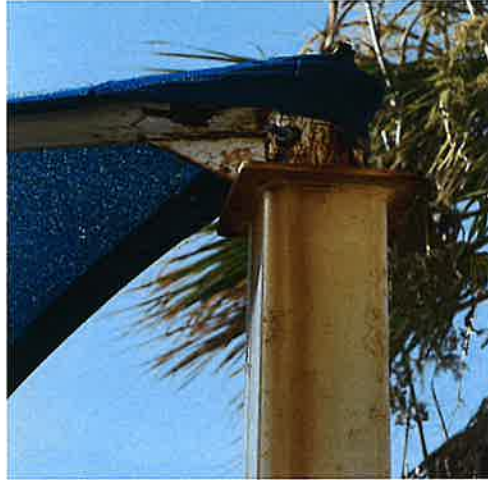
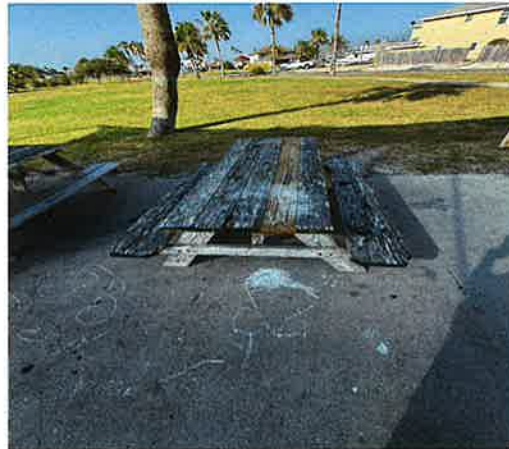
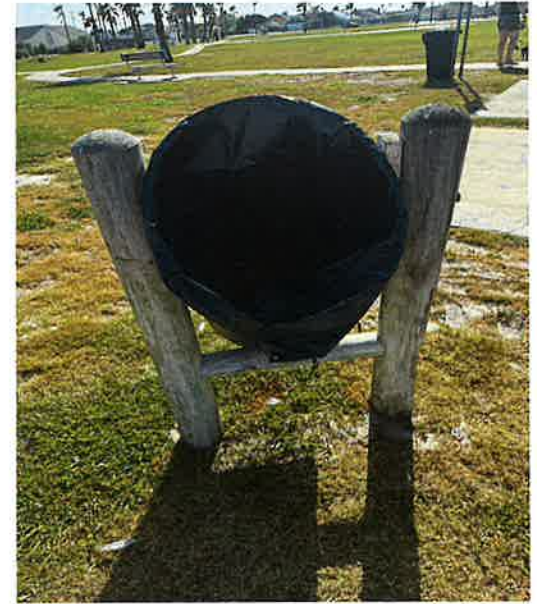
Picnic Amenities

- Picnic tables are in poor condition and require full replacement
- Trash cans need to be replaced due to wear and condition

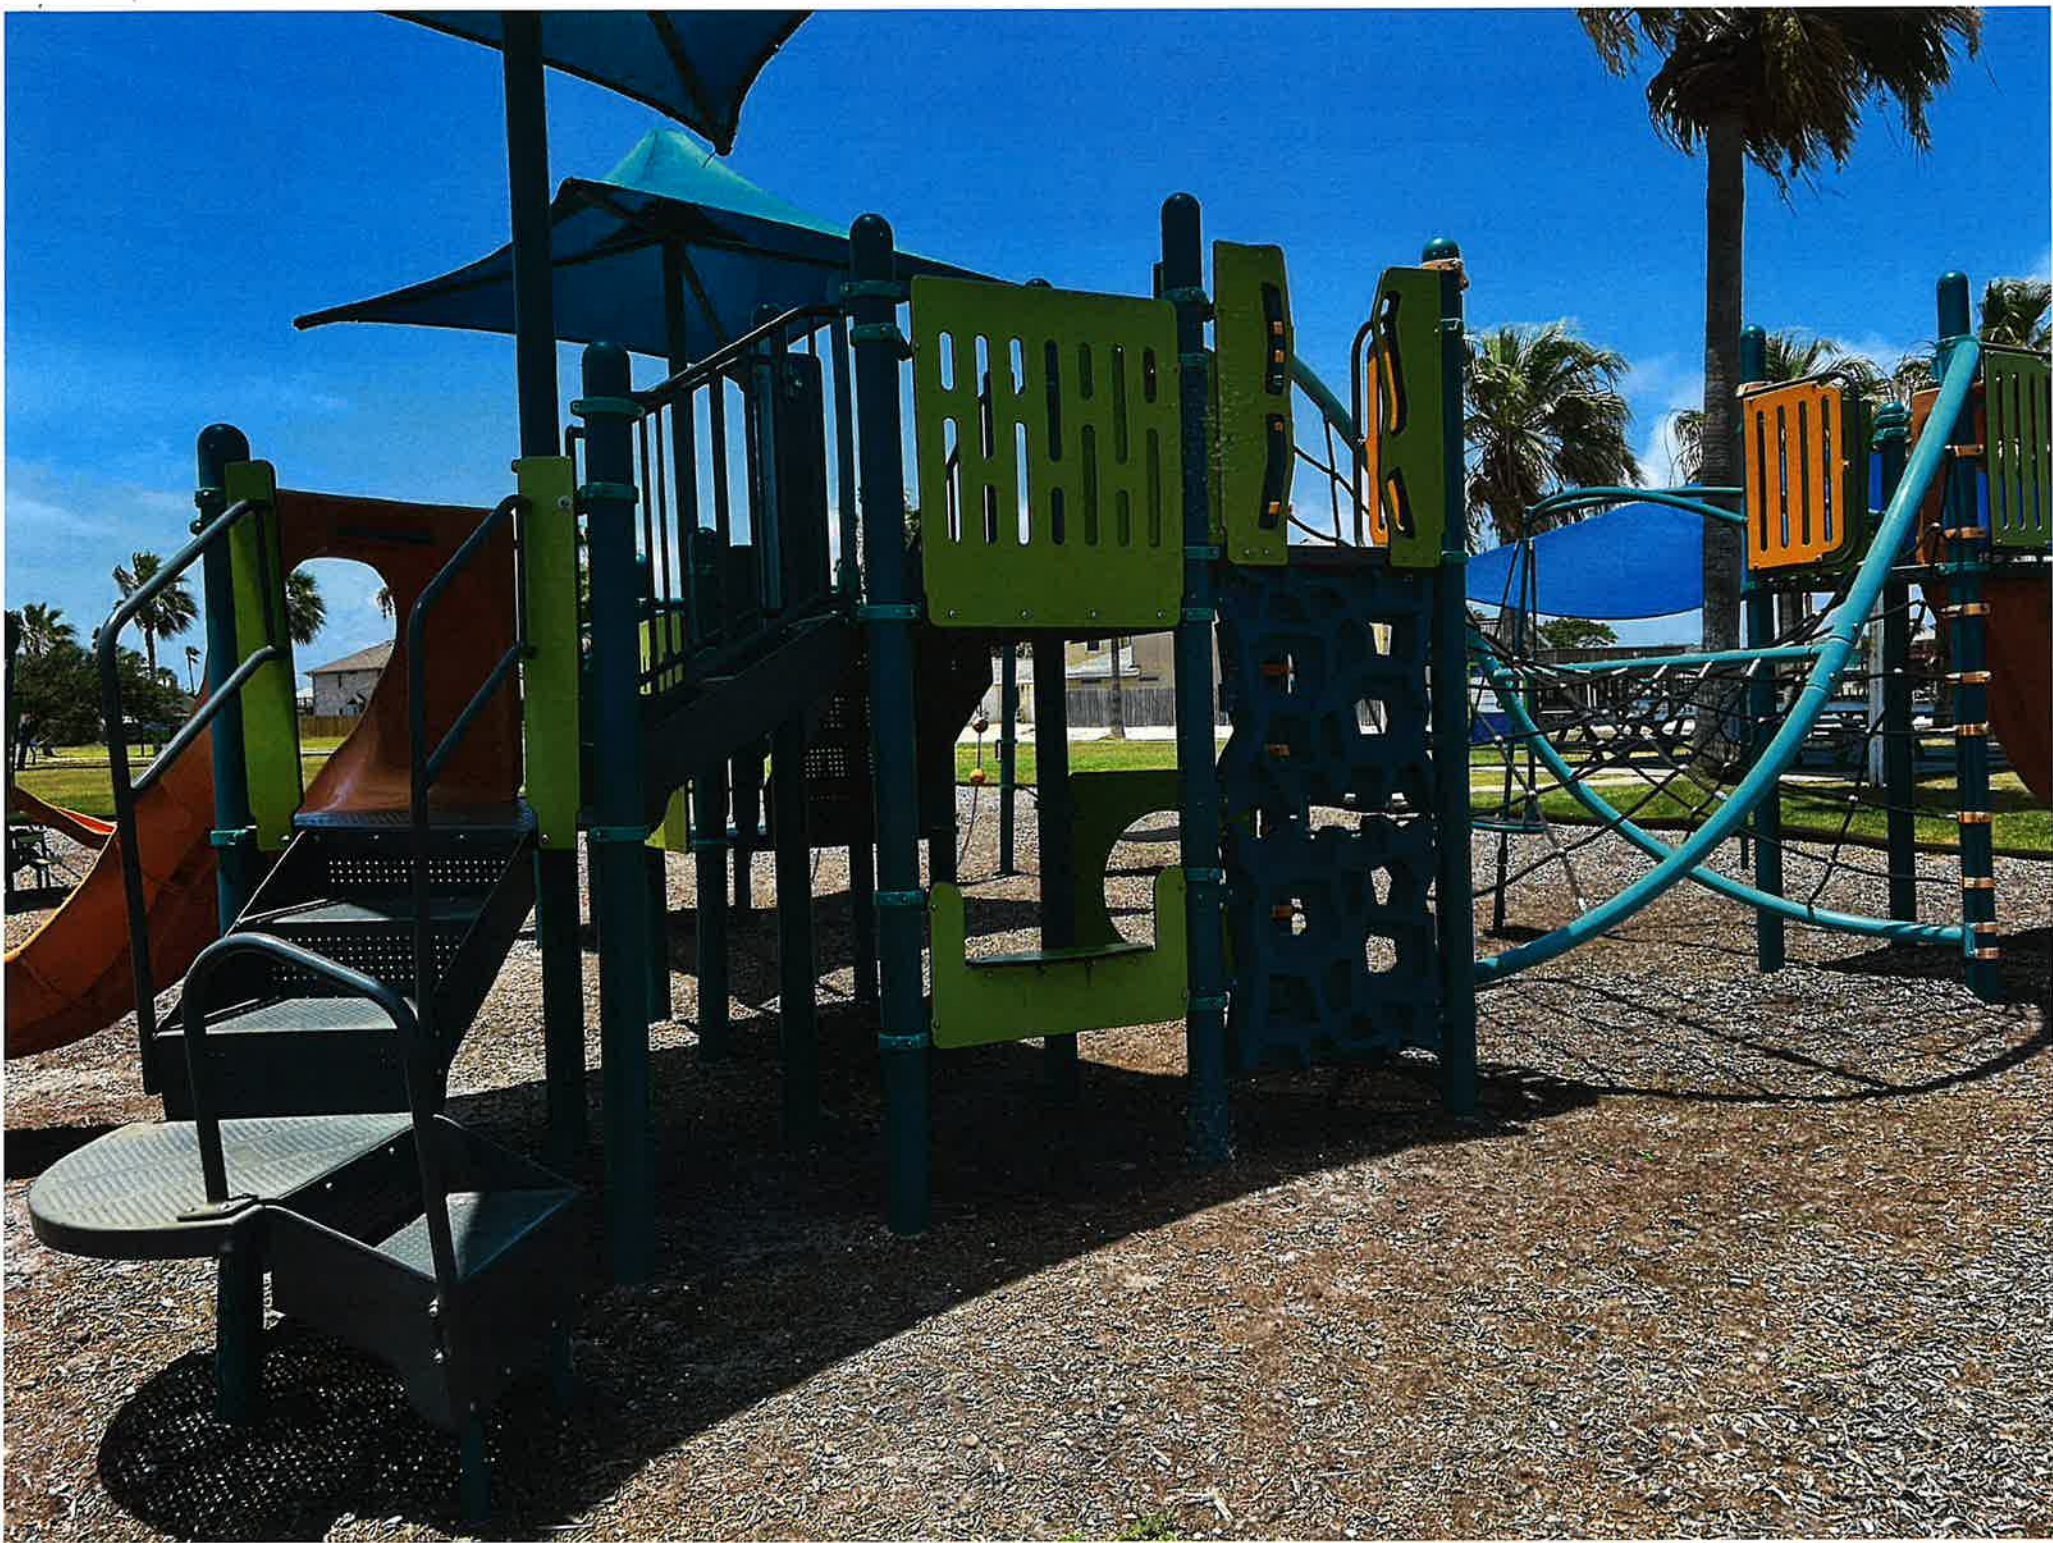
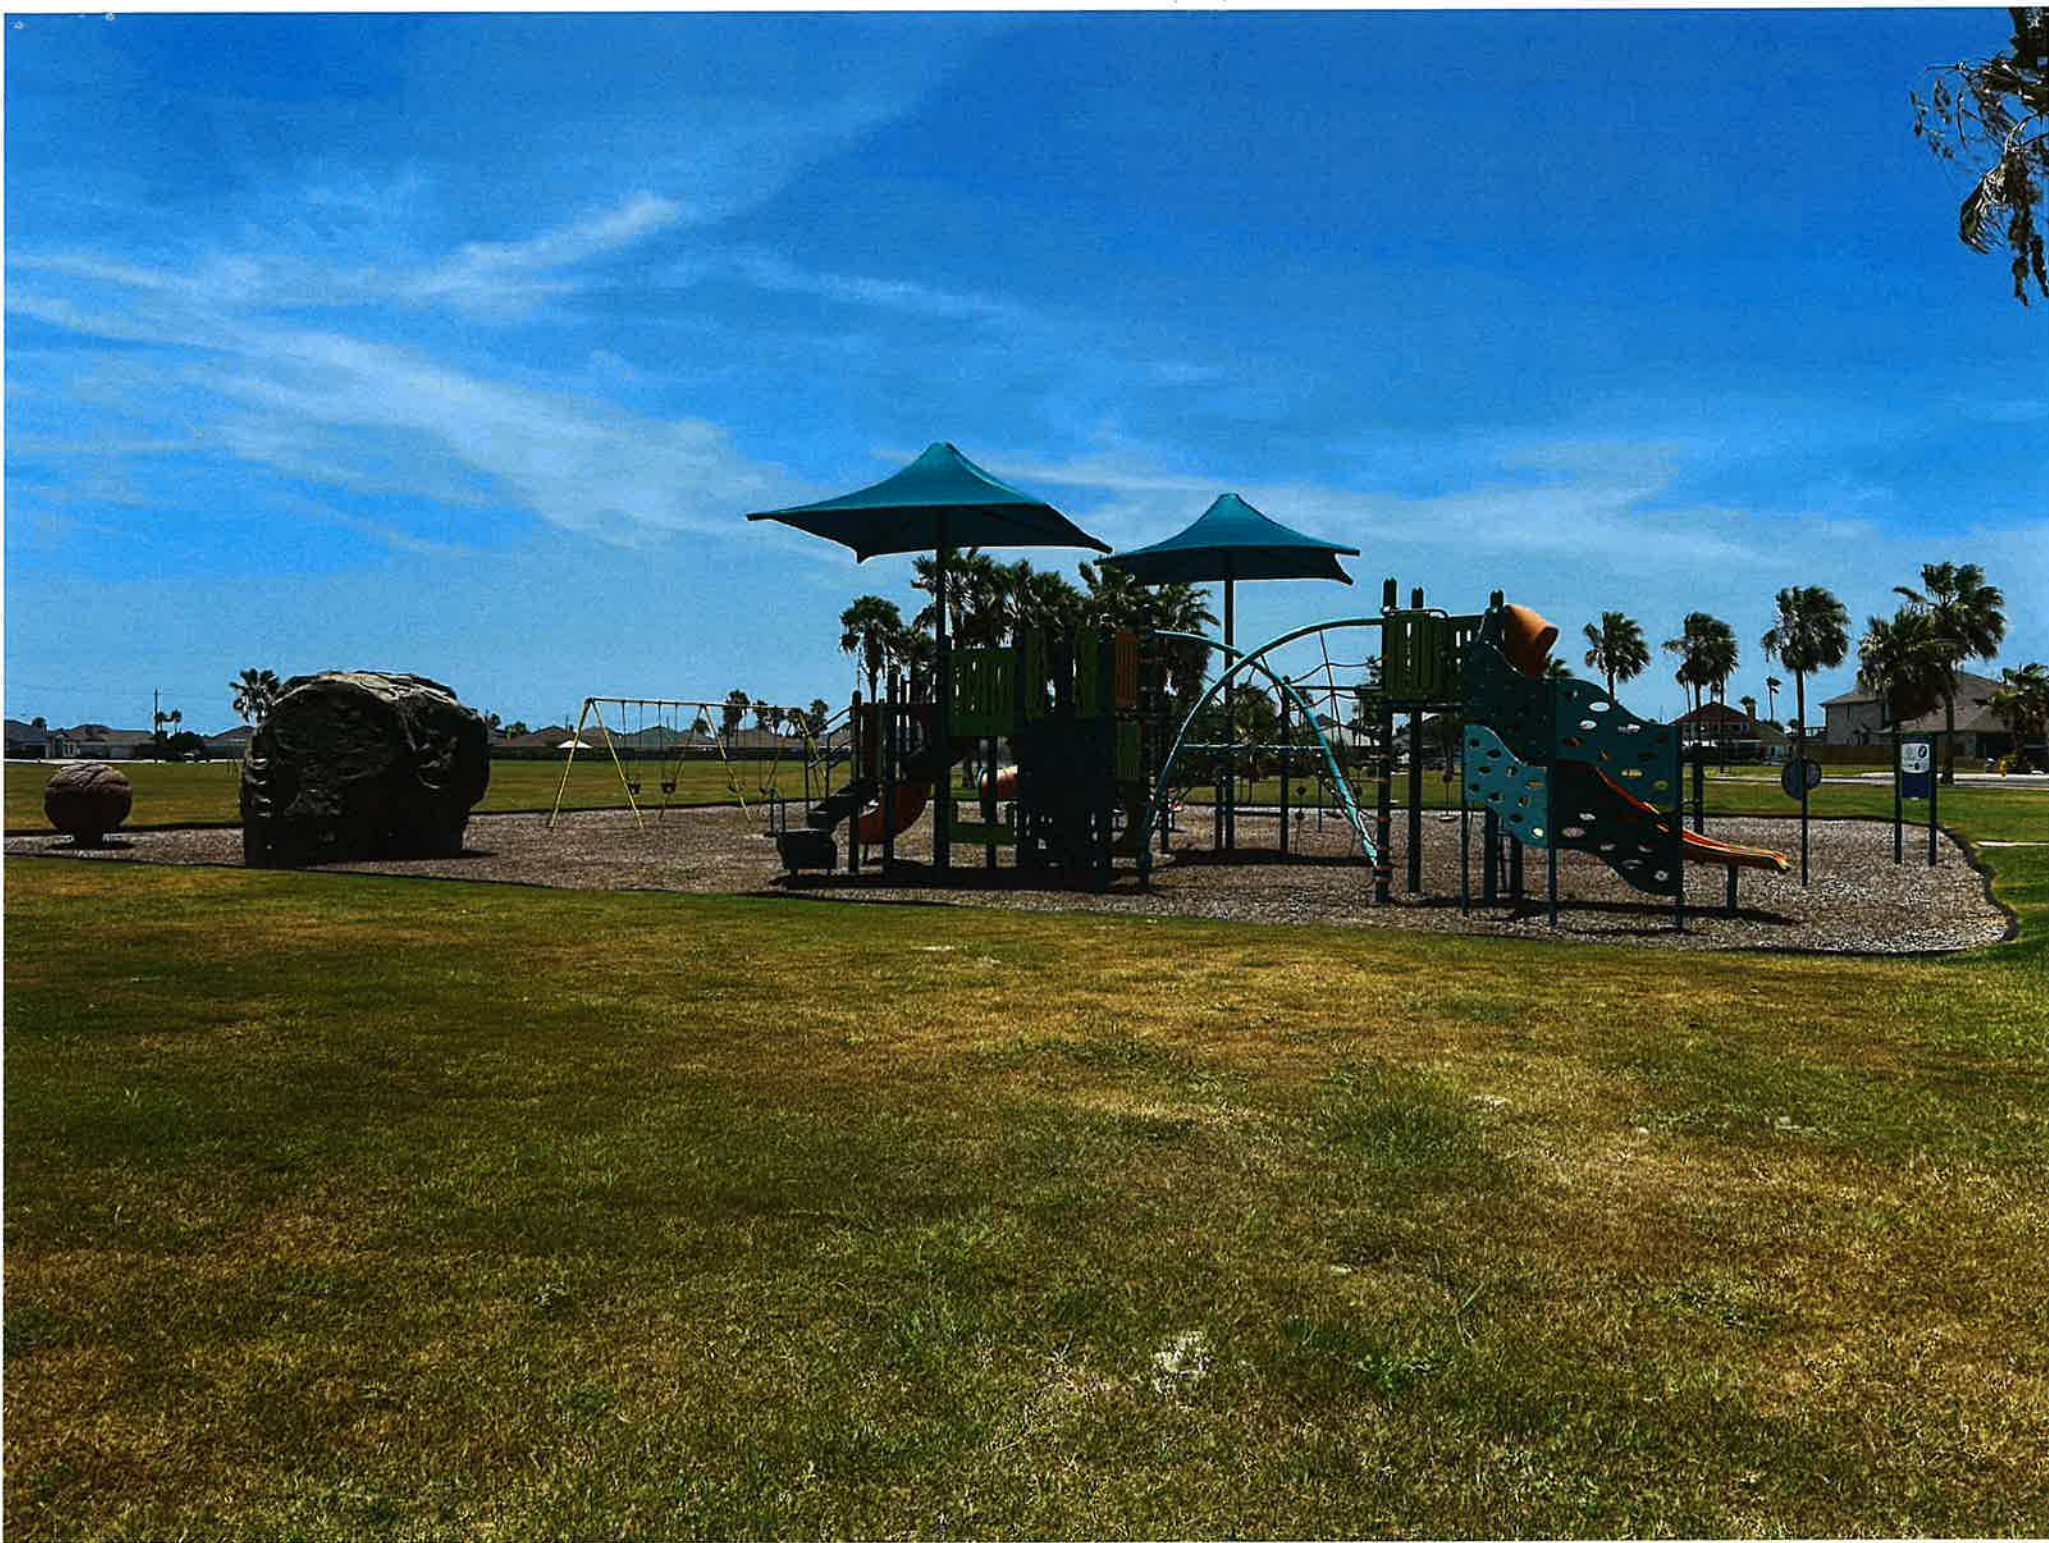
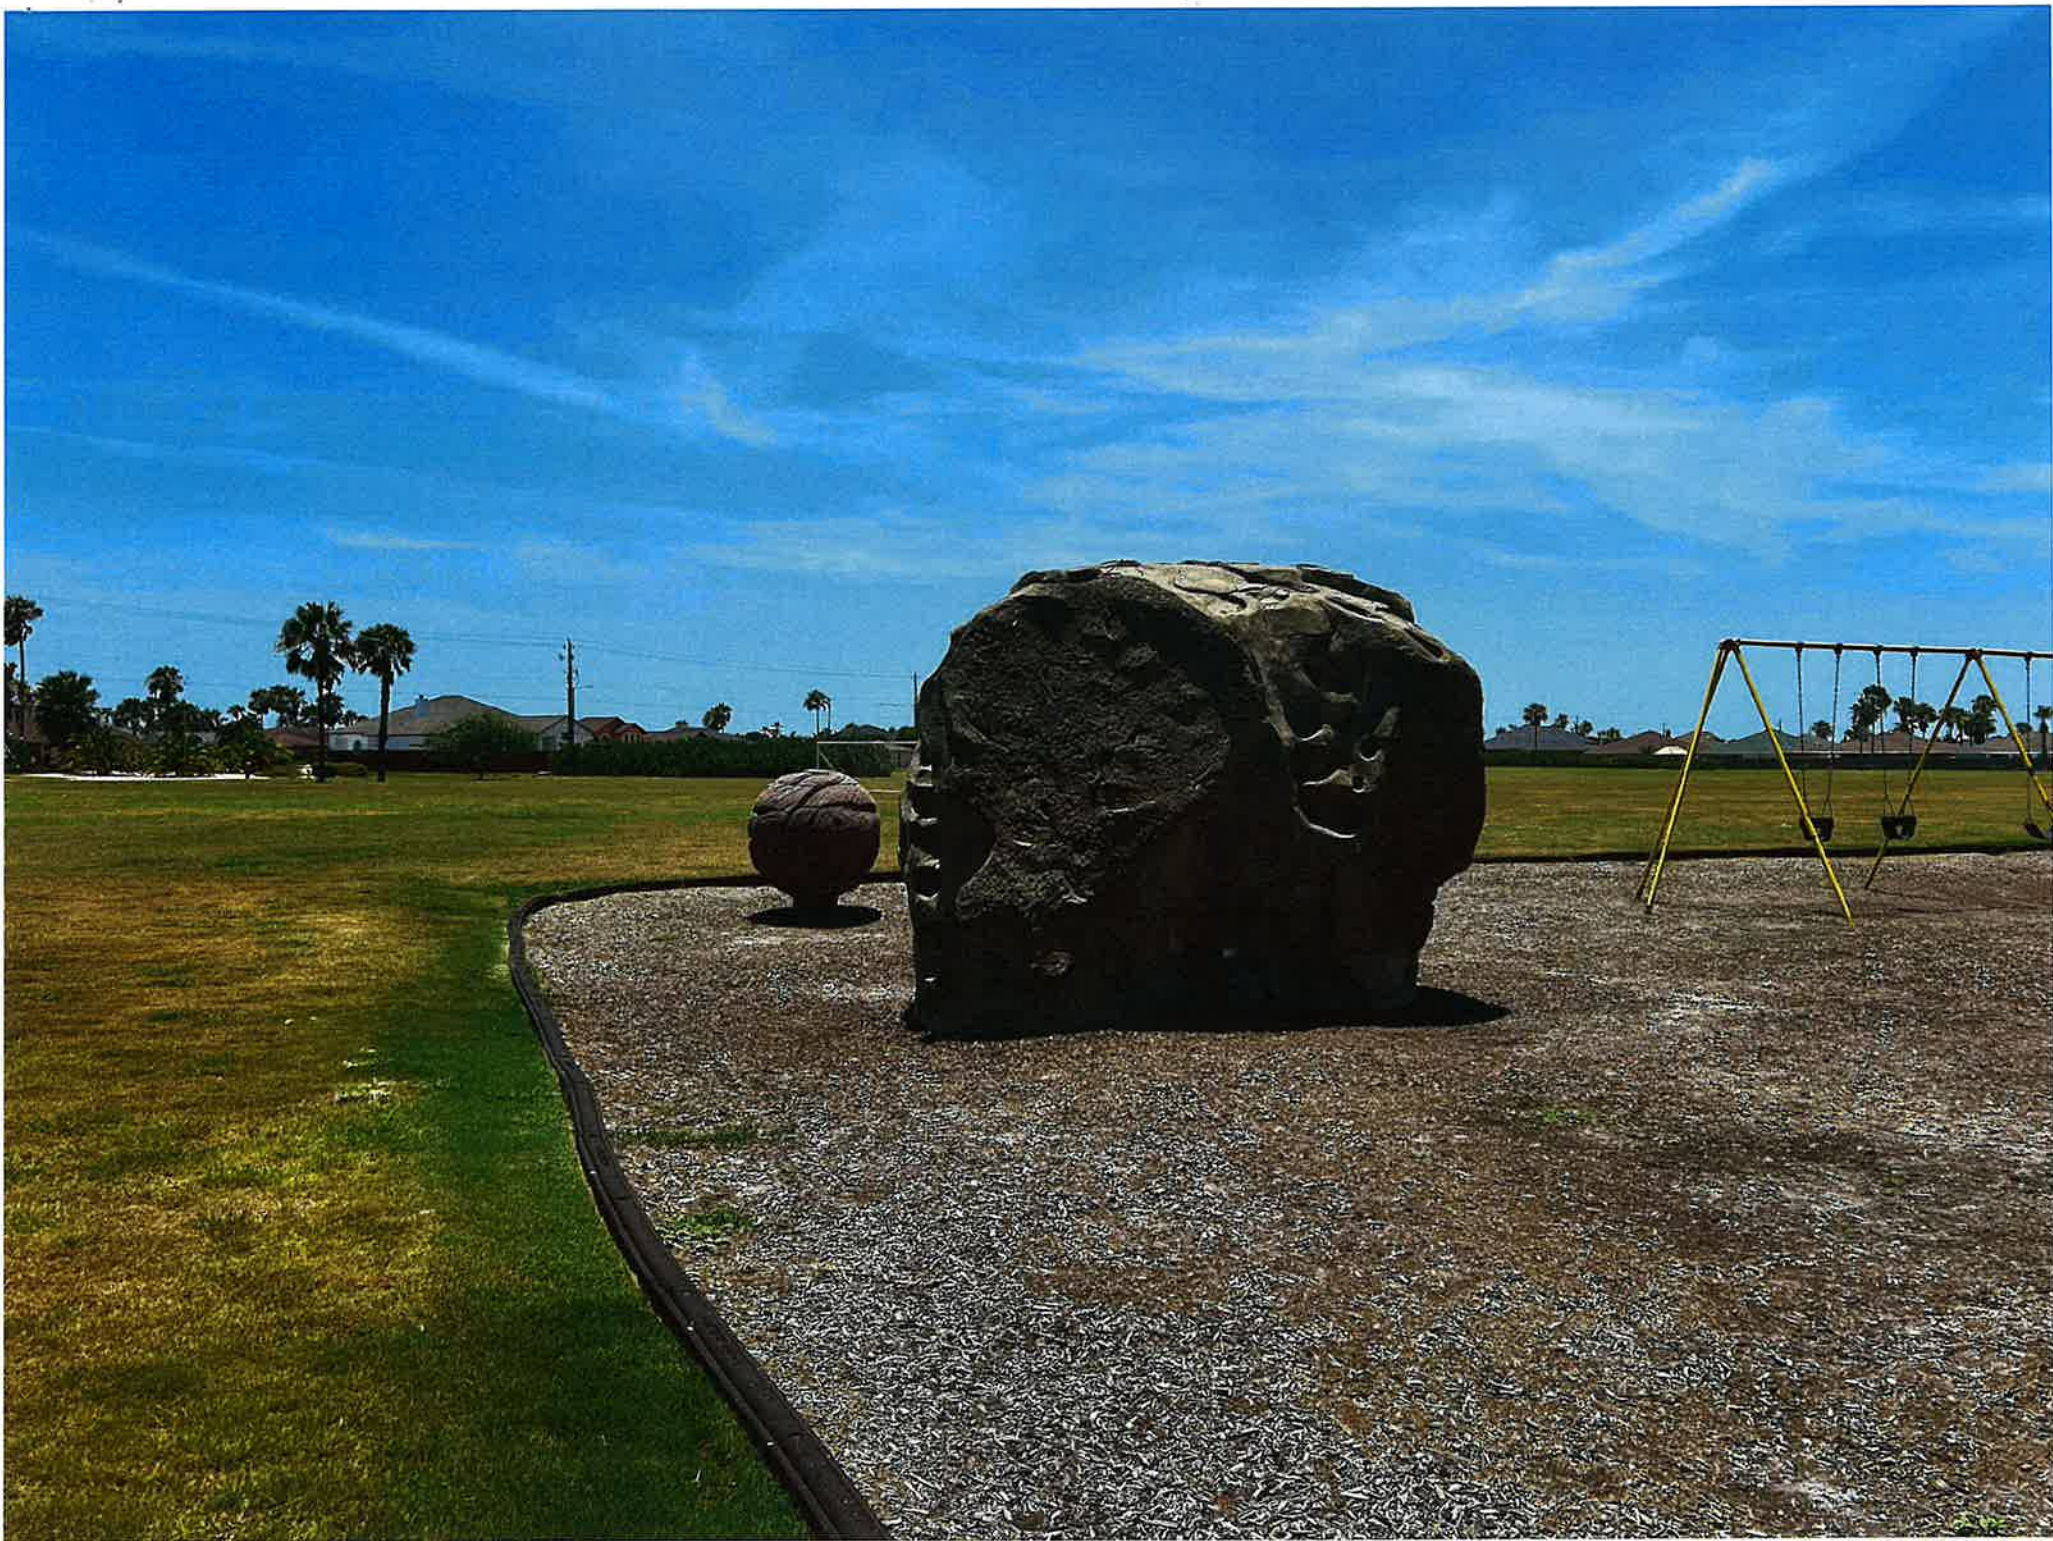
- **Pavilion Structure:**

- **Shade Covering:**

- Existing shade structure is rusted through
- Requires a new shade canopy installation

- **Site Amenities:**
