# LEVEL 1 REPLACEMENT RESERVE REPORT FY 2024 HIGHLAND MANOR COMMUNITY ASSOCIATION INC.

# HIGHLAND MANOR COMMUNITY ASSOCIATION INC.

HAGERSTOWN, MARYLAND February 7, 2023 Revised March 21, 2023

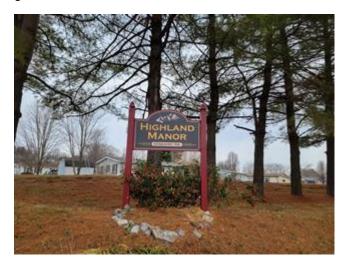
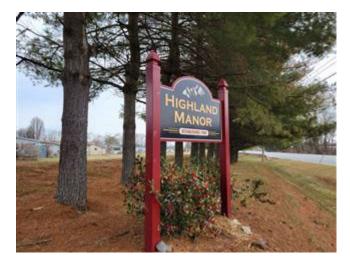
**Entry Monument and Signage.** The Association maintains an entry monument at the main entrance to the property. The monument is made of painted wood with painted wood supports. The monument was observed to be in good condition overall.

To keep the monument fresh and appealing, we recommend regularly cleaning, repairing, and refinishing the monument as needed and replacement every 10 to 15 years.

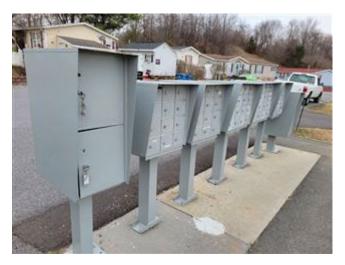
**Mailboxes.** Cluster mailboxes are located throughout the community. The mailboxes were observed to be in good condition overall.

Mailboxes should be maintained to the extent that rust does not develop on the structure or pedestal, and all mail slot doors remain intact with operable hinges and locks. Our replacement estimate assumes that these units will be replaced with fiberglass or composite units in the future.

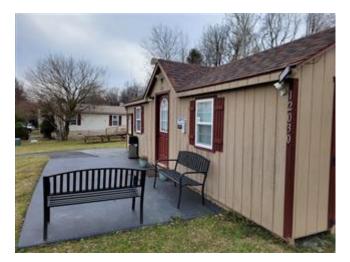
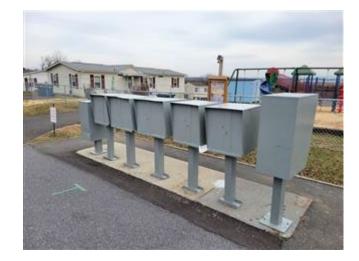
**Concrete Work.** The concrete work includes the community mailbox cluster pads and pads at the exterior of the management office. The concrete work was observed to be in good condition overall.

The standards we use for recommending replacement are as follows:

- Trip hazard, 1/2 inch height difference.
- Severe cracking.
- Severe spalling and scale.
- Uneven riser heights on steps.
- Steps with risers over 81/4 inches.

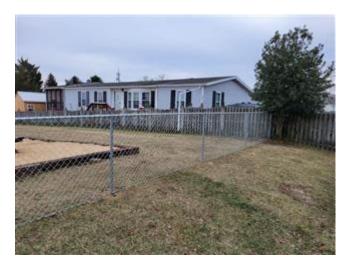
**Fencing.** The Association maintains 4', 6', and 10' high chain-link fencing at the upper playground area. The fencing is new and was observed to be in good condition. Fencing systems have a large number of configurations and finishes that can usually be repaired as a maintenance activity by replacing individual components as they become damaged or weathered.

Protection from string machine damage during lawn maintenance can extend the useful life of some fence types. Protection from this type of damage is typically provided by applying herbicides around post bases or installing protective sheathing.

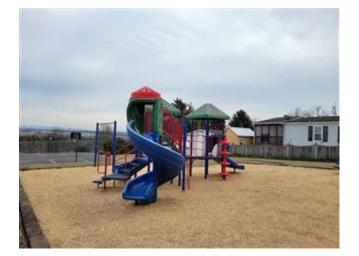
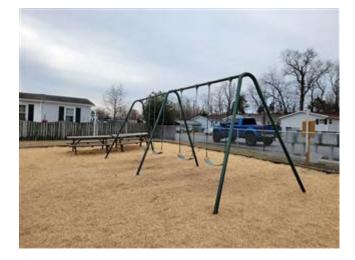
**Tot Lots.** The community maintains two (2) tot lots on the property. These tot lots include play structures, swingsets, wood borders, and a wood chip surface. The facilities are in generally good condition with minor wear. The wood chip surface was observed to be in good condition overall and providing adequate coverage.

The safety of each individual piece of playground equipment, as well as the layout of the entire play area, should be considered when evaluating a playground for safety. The installation and maintenance of the protective surfacing under and around all equipment is crucial. Please note that the evaluation of the equipment and these facilities for safety is beyond the scope of this work.

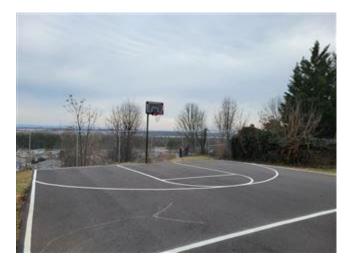
**Basketball Court.** The community maintains a full asphalt basketball court. The court was observed to be in good condition overall.

Replacement of nets, hoops, and backstops is considered a maintenance activity and is therefore not included in the study. Repaving, color coating, and entire goal replacement are included.
